# COMBINED CYCLE Journal

## Repair technologies borrowed from aeros produce high yields on F-class blades, vanes

The value of real partners was illustrated during the recent refurbishment of stage 2 and 3 blades and vanes for a V84.3A1 peaking unit at Kansas City Power & Light Co's (KCPL) Hawthorn station, located a few miles from the Kansas City airport. The gas turbine (GT) was taken out of service in spring 2004 for a hot-gas-path overhaul after compiling 25,000 equivalent operating hours (EOH) on turbine blades and vanes.

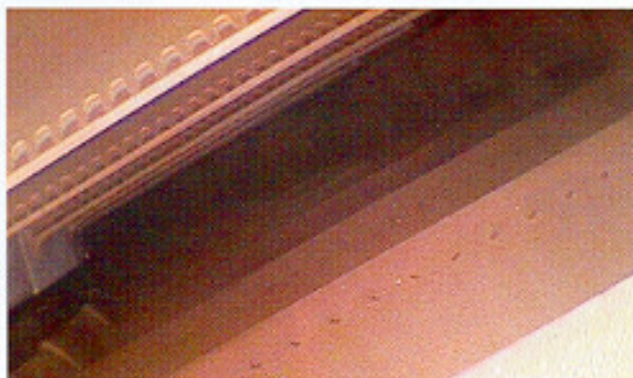
**Results.** The repair project described in detail below met the utility's expectations on schedule, cost, and quality, added Scardino. The quality aspects of the repairs were confirmed by a thorough borescope inspection in January 2005, after a demanding 3300 hours of service and 100 starts since project completion in early May 2004.

The inspection revealed that refurbished components were in excellent condition (Fig 1). In particular, the upgraded coating system prescribed by Liburdi did not crack like the original coating, and high-tech trailing-edge repairs to second-stage vanes using a proprietary Liburdi process were defect-free.

1. Borescope inspection after 3300 hours of service and 100 starts following completion of repairs showed refurbished parts were in excellent condition

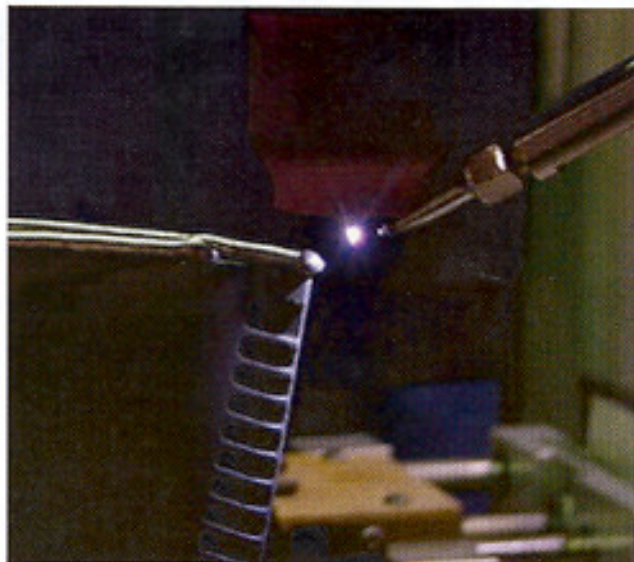
2. Automated micro-plasma welding process works well on single-crystal stage 2 blade material

For rebuilding stage 2 blade tips, Liburdi selected an advanced weld alloy with high oxidation resistance—a material that offers greater resistance to oxidation than that used for the original blade casting. This upgrade, said Cooke, would reduce or eliminate future oxidation in service, based on previous experience in high-temperature aeroderivative engines. The single-crystal stage 2 blade material responded successfully to the

automated micro-plasma welding process (Fig 2) that had been used by Liburdi many times previously in similar situations.

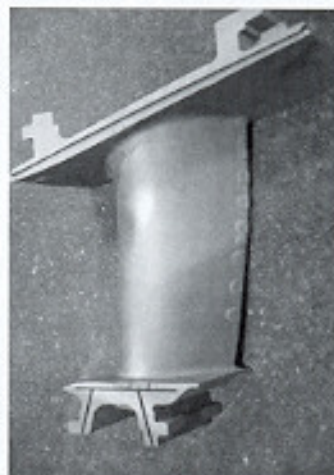
3, 4, 5. LPM powder metallurgy process repairs trailing-edge cracks (above); airfoil after blending to restore the original profile is at right

**The stage 2 vanes,** made from high-strength nickel alloy castings, exhibited extensive cracking in the trailing edges. These cracks also were repaired using the LPM process (Figs 3-5). Incoming trailing-edge cracks are at the left in the group of photos, top right shows cracks repaired with LPM materials after vacuum heat treatments,

and the airfoil after the LPM repairs were blended to restore the original profile is at lower right. In sum, the LPM process was selected over welding to permit use of the latest proven high-strength repair materials and to ensure a high repair yield by avoiding potential welding problems.

Liburdi's patented LPM power metallurgy process, which relies on superalloy powders for strength, allows repairs without any of the HAZ problems associated with welding. The process used frequently by the company and is authorized by both aeroderivative and frame OEMs for both repairs and new-parts manufacture.
